Extension of a Concrete Shaft Lining at the Cote Blanche Mine, Louisiana, USA

D.E. Hart¹ and John Fallis²

ABSTRACT

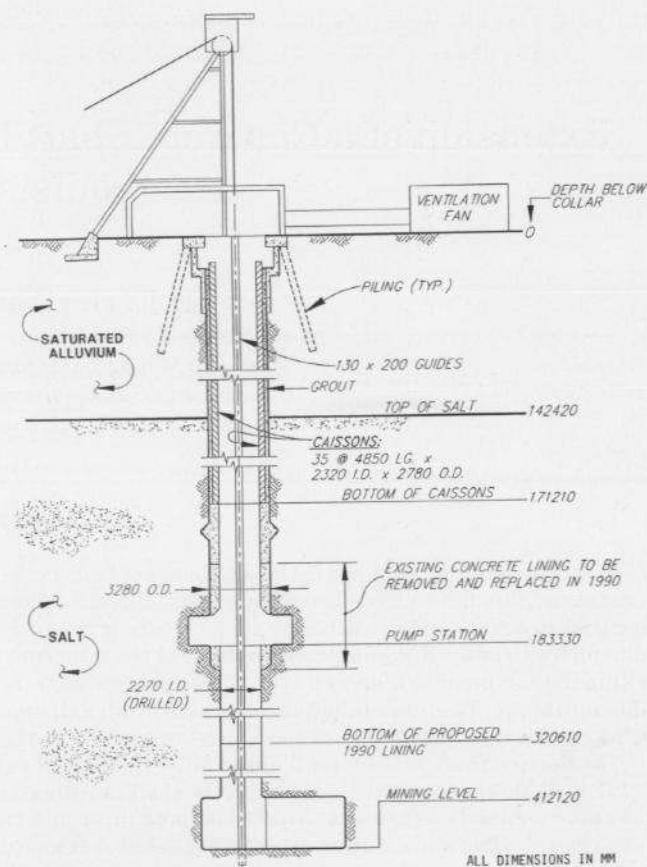
Figure 1 is a section through the Service Shaft showing as-built conditions after construction in 1963, when it was used for hoisting development salt while construction of the Production Shaft was being completed. The total shaft depth is 412 m from surface to the mining level. The 2320 mm inside diameter concrete liner extends 180 m from surface to the top of the pump station. This places the liner bottom 38 m below the top of the salt, where the top of the salt reaches to 142 m below surface. Below the pump station, except for a concrete collar at the floor, the shaft is an unlined 2270 mm diameter excavation in the salt. The water table is at sea level, approximately 12 m below surface at the shaft collar. The geological section is simple, showing only alluvium and salt, with the alluvium consisting of saturated sands, silts, and clays.

Fig. 1. Section through service shaft as built in 1963.

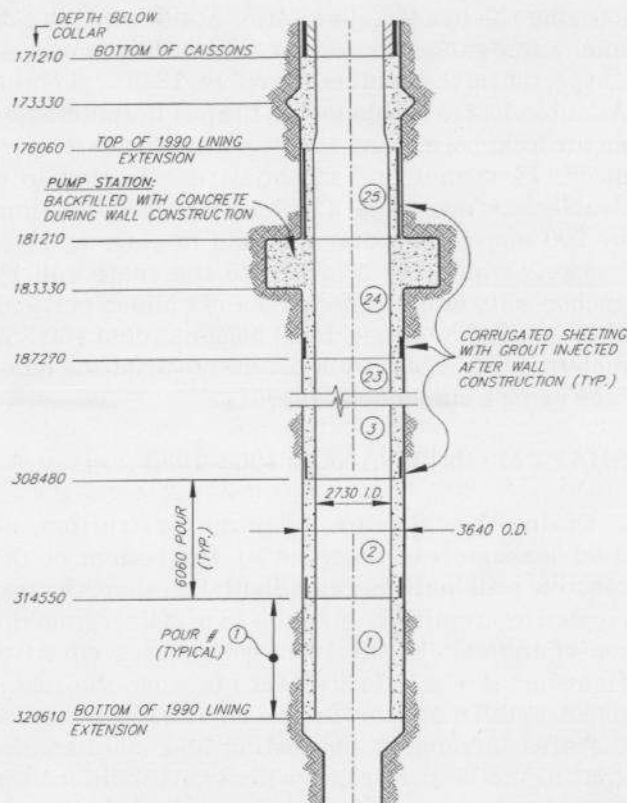
The lining extension is shown in Figure 2. It is an unreinforced concrete cylinder with a 2730 mm inside diameter and a 460 mm wall thickness. The concrete has a design strength of 40 MPa and was made up using brine instead of fresh water in order to be compatible and bond with the salt wall. The structural strength of the cylinder is adequate to resist the hydrostatic pressure exerted by a column of brine originating from surface. However, due to the nature of concrete, the wall is not totally water

Fig. 2. Section through service shaft showing 1990 lining extension from depth 176,060 mm to 320,610 mm.

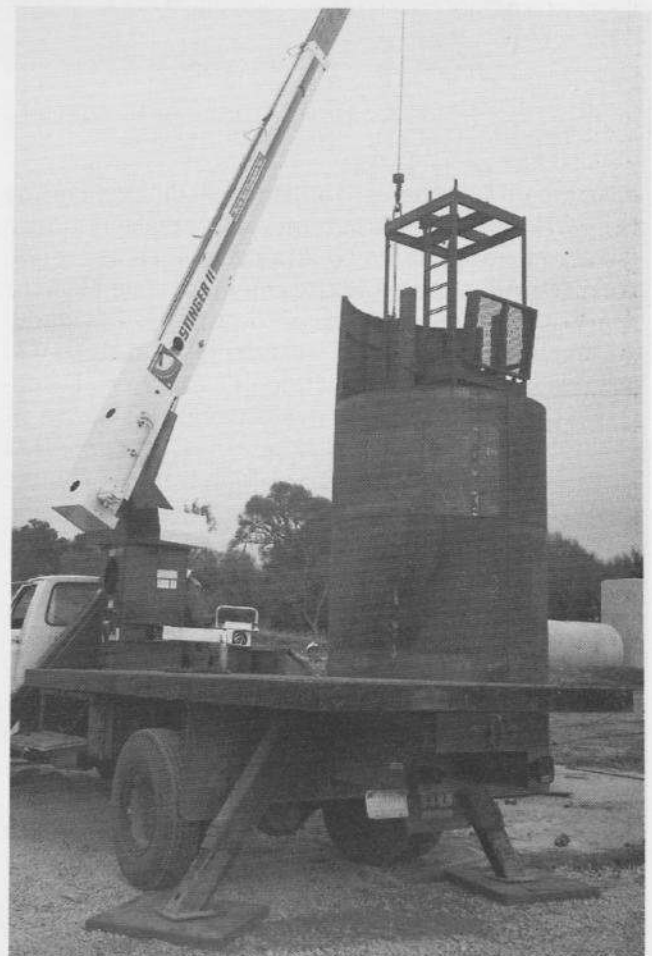
Fig. 3. Assembly of concrete form and 3 deck scaffold on surface. Assembly includes a pair of guides and guide brackets to ensure an exact fit of all components and to train crews in their use.

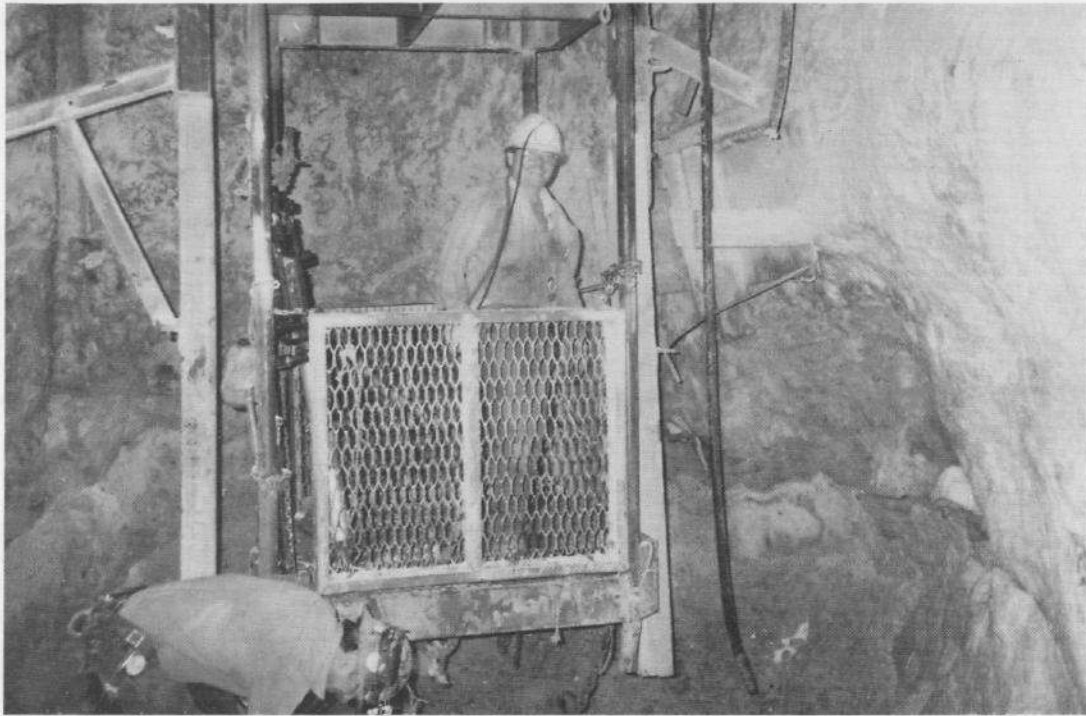
Fig. 4. Mine level shaft station showing bottom deck of the 3 deck scaffold suspending below the man-cage.
